Type B Accident
Investigation Board Report
on the July 7, 1997
Industrial Accident
at the
Knolls Atomic Power Laboratory-
Windsor Site

Schenectady Naval Reactors Office
U. S. Department of Energy

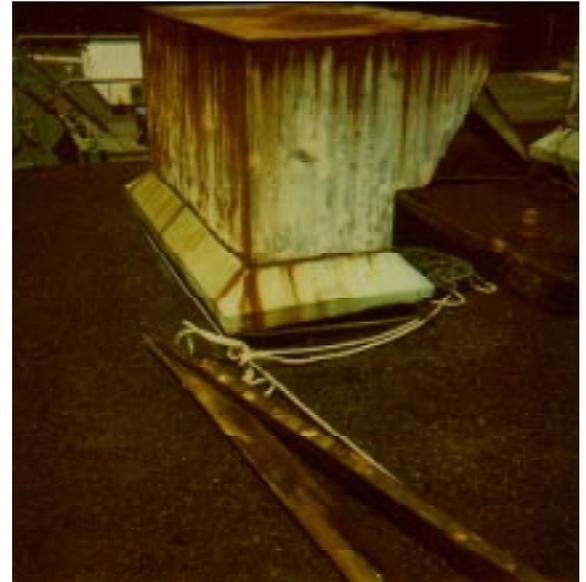
Subject's lifeline anchor point

the two laborers were two vents which had been determined by EB the previous week to be structurally adequate for this purpose in accordance with OSHA 29 CFR 1926.502(d)(15). The subject began working on the southeast corner of the Building 5 roof and worked his way north. The other laborer began on the southwest corner and worked north (with the intention of meeting in the center of the north edge).

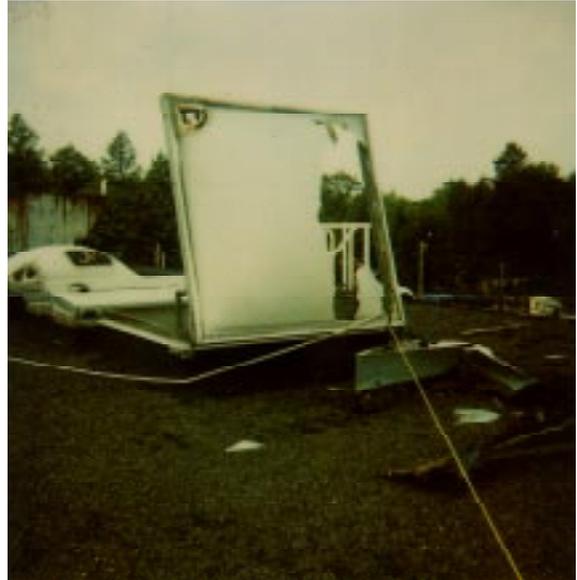
Photograph of skylight viewed from east to west

- A post accident analysis of a piece of the broken plastic skylight dome identified the material as poly (methyl methacrylate). This material is known by the trade names Plexiglas and Lucite and is widely used for window glazing and similar applications. Poly is subject to damage from UV radiation, such as is present in natural sunlight. This damage weakens the material and makes it brittle. Physically, this damage, if present, is visible as a network of tiny cracks on the surface of the material, a phenomenon known as crazing. Extensive crazing is evident on the poly sample from the Building 5 skylight. The extent of crazing present implies that the sample is brittle and substantially weaker than the new product.

- Senior KAPL and EB management focused on waste management and environmental regulatory compliance.
- The Plexiglas dome of the skylight was substantially weaker than new product as a result of UV damage due to 38 years of exposure to sunlight.

2. NSC failed to comply with its Health and Safety Manual invoked by paragraph I.F of Safety Specification S-12. A fall protection plan for the roof work was not prepared. A properly prepared fall protection plan would have required the skylights to be covered or guarded.	Fall protection plans should be prepared by NSC and approved by both Olshan and/or EB prior to the start of elevated work. These plans should be specific to the work site and be checked against all applicable safety requirements.

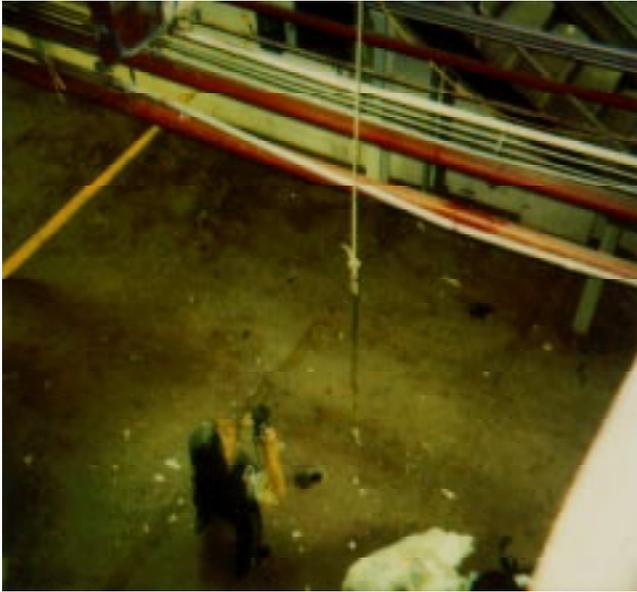
Metal conduit and firemain pipe struck by subject during descent

During his descent, the subject struck a conduit and a fire main piping, which absorbed some of the energy and slowed the downward acceleration. He may also have contacted a metal stair handrail. The fall was arrested prior to the subject's torso striking the building floor when his lifeline became entangled with the skylight hatch coaming and a small diameter nylon rope being used as an OSHA control line to identify areas requiring fall protection on the roof. The skylight was not identified as a fall hazard and was not in an area where fall protection was deemed necessary. The subject's torso was approximately one foot above the floor with his lower extremities contacting the floor when his lifeline became taut.

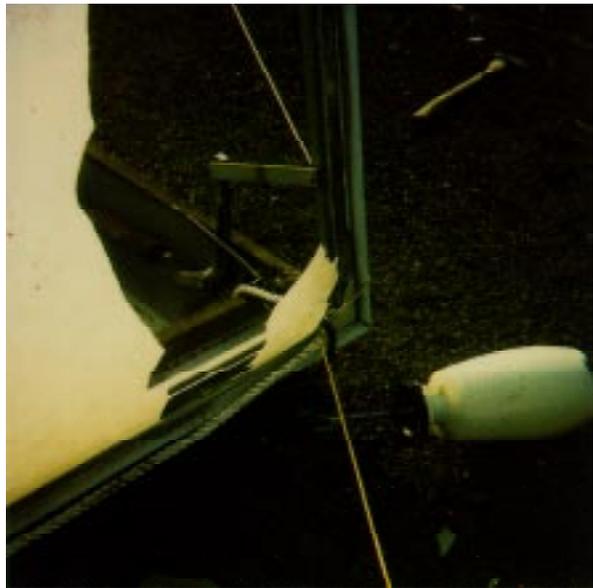
Lifeline entangled with the small diameter control line

The NSC Superintendent established an area on the Building 5 roof requiring fall protection and replaced two lines that were previously installed to identify a path of travel to ladder ways on the Building 5 roof. However, the new control lines did not demarcate the six-foot distance from the Building 5 roof edge, nor were the control lines installed around the Building 5 skylights. A properly prepared fall protection plan would have identified control lines six feet from the roof edge and the skylights. The lifeline tie-off points established on the Building 5 roof limited the potential fall distance to six feet in a small area of the roof which necessitated constant attention to adjusting the length of the lifeline as roof work progressed around the roof edges. A properly prepared fall protection plan would have identified a more reliable lifeline tie-off system.

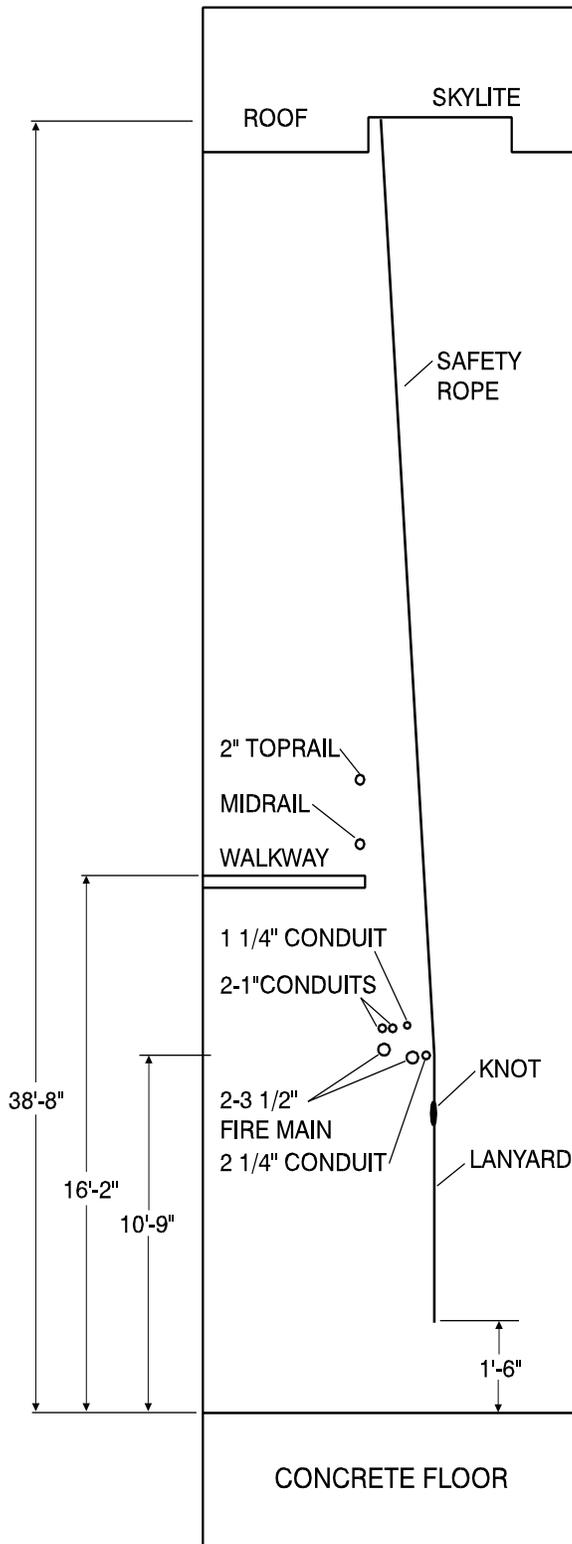
1. THE 2-1/4" CONDUIT WAS DEFLECTED DOWNWARD 10" TO THE CURRENT POSITION.
2. NO OTHER COMPONENTS WERE NOTED TO BE OFF LOCATION.
